PHASE I REPORT
NATIONAL DAM INSPECTION PROGRAM.

NAME OF DAM: Milburn Spring Dam
STATE LOCATED: Pennsylvania
COUNTY LOCATED: Bedford
STREAM: Unnamed tributary of Cumberland Valley Run
SIZE CLASSIFICATION: Small
HAZARD CLASSIFICATION: High
OWNER: Borough of Bedford
DATE OF INSPECTION: November 19 and December 12, 1979

Reservoir (NLI ID Number P1 00237,
DEM ID Number 57)
Susquehanna River Basin, Unnamed
Tributaries of Cumberland Valley
Run, Bedford County
Pennsylvania, Phase I
Inspection Report

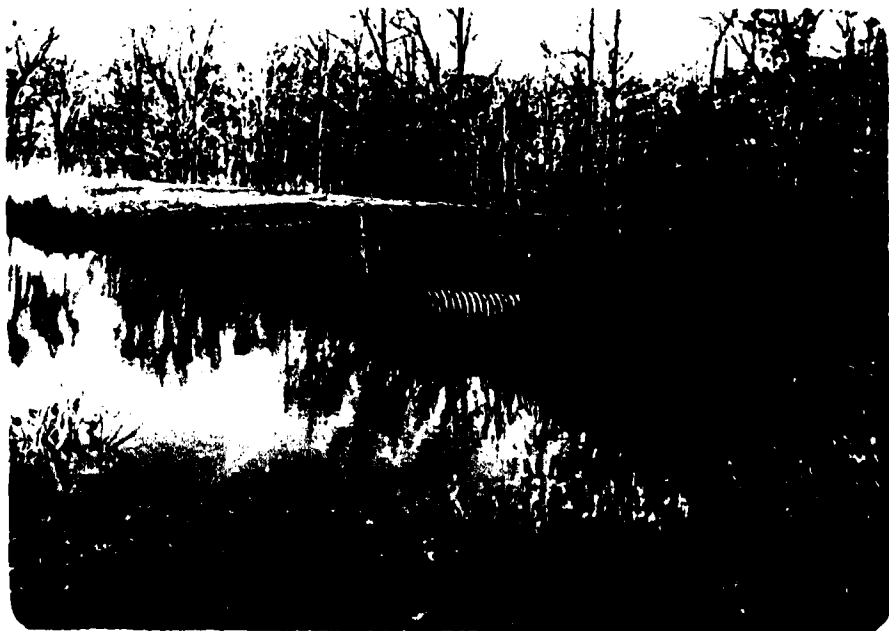
Photograph No. 2

c. Appurtenant Structures. The appurtenant structures for the dam consist of overflow pipe and outlet works. The overflow pipe was found to be in good condition. No signs of deterioration were noted.

Eighteen-inch-diameter CMP spillway.

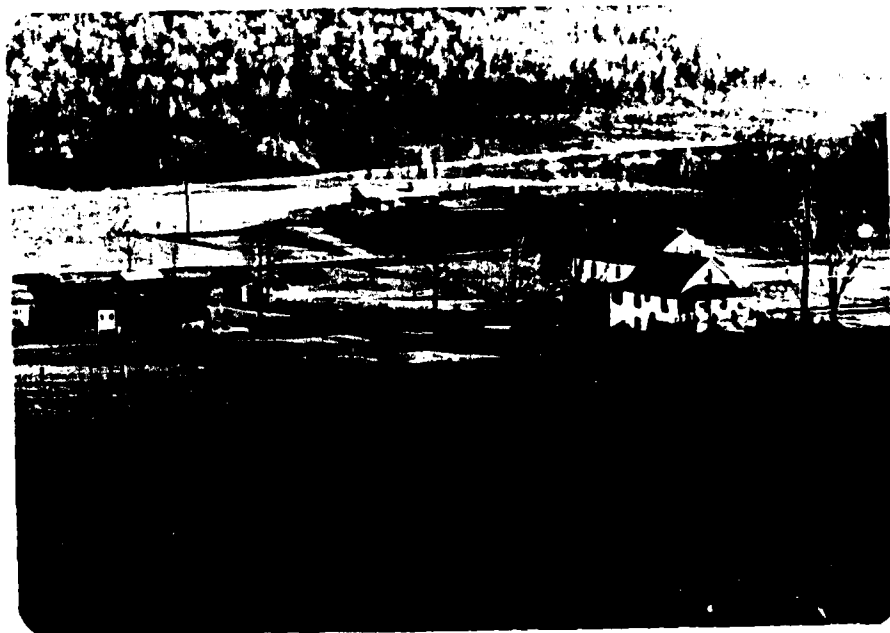
Photograph No. 6

Homes located 1/2 mile downstream from the right abutment.

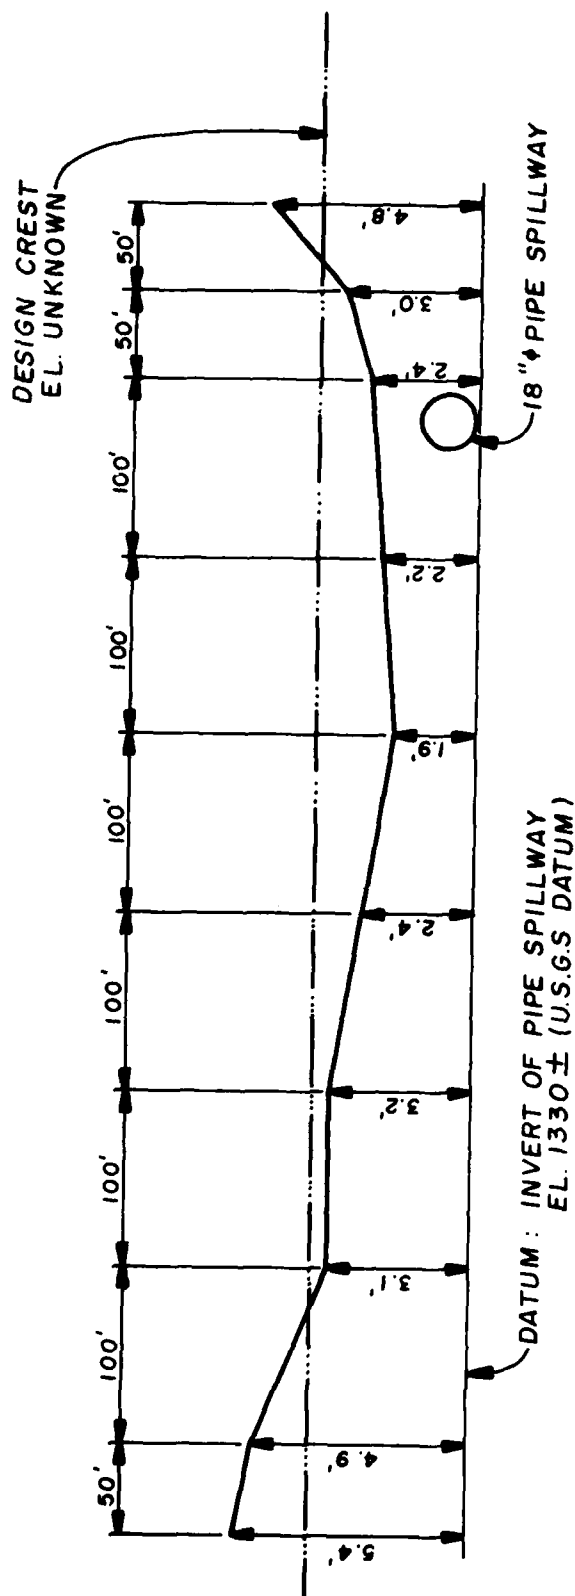
DAM CREST PROFILE (LOOKING DOWNSTREAM)

The crest of the dam was surveyed relative to the intake invert elevation of the outflow pipe. The freeboard was found to range from 1.9 feet near the northern corner of the reservoir to 5.4 feet on the left abutment. The dam crest profile is illustrated in Plate 5.
